Troubleshooting Overview

This chapter provides information for troubleshooting automated DNA sequencing results from capillary electrophoresis runs.

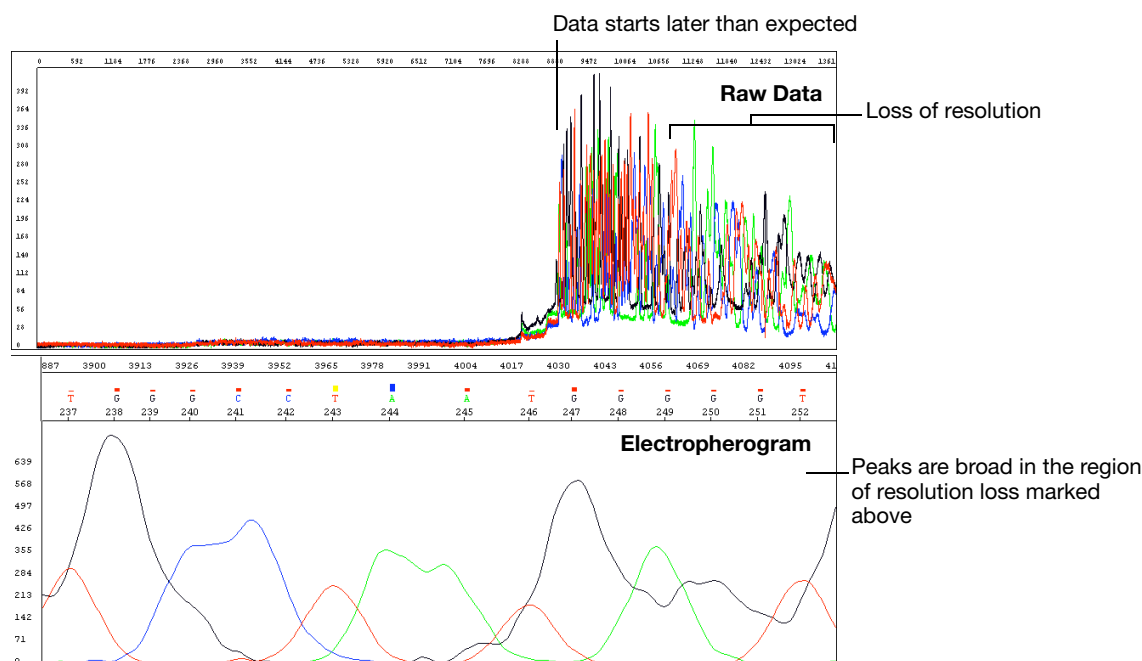
Signal starts later than expected: with resolution loss

Possible Cause(s)	Recommended Action
Electrophoresis issues:	
Capillaries overloaded with sequencing product, possibly unlabeled DNA or RNA.	Click the Annotation tab and examine the Ave Signal Intensity. Excessive signal: <ul style="list-style-type: none"> 3730/3730xl instruments: >10,000 rfus 310 and 31XX instruments: >1000 rfus Re-inject the samples using decreased injection time and/or lower voltage. Load less labeled sample by using less template in the sequencing reaction (see Table 8, "Recommended DNA template quantities for cycle sequencing," on page 63).
Temperature in room and/or oven fluctuating.	Review the EPT tab using Sequencing Analysis Software (see page 198). If the oven temperature is fluctuating, the oven may be leaking because of a poor seal. Contact Applied Biosystems to arrange a service engineer visit.
Contaminant migrated through the capillary during electrophoresis.	Run the sample again.

Capillary not filling.	Check the pin valve in the polymer block, amount of polymer in the bottle, leaks in the check valves, and polymer pump function. Contact Applied Biosystems to arrange a service engineer visit.
Temperature in the array heater fluctuating more than $\pm 0.5^{\circ}\text{C}$ (3730/3730xl and 3130/3130xl instruments and POP-7 only).	Using Data Collection Software, check the array heater temperature. If it fluctuates more than $\pm 0.5^{\circ}\text{C}$, contact Applied Biosystems to arrange a service engineer visit.

Possible Cause(s)	Recommended Action
Water in polymer system caused by insufficient flushing after water wash maintenance.	Flush the polymer, using the wizard if possible.
Extension products purified using bead-based kits were injected without removing the magnetic beads. The beads may interfere with the extension products during injection and cause overloading or other injection anomalies.	Remove magnetic beads before loading the sample.
Variables that affect current set incorrectly.	<ul style="list-style-type: none">• Replace buffer in system with fresh 1X running buffer.• Inspect system for leaks (wet or dry polymer around fitting indicates a leak) and tighten fittings as needed.• Look for discoloration in the block channels or tubing. If present, perform a water wash on the system using the wizard in Data Collection Software.

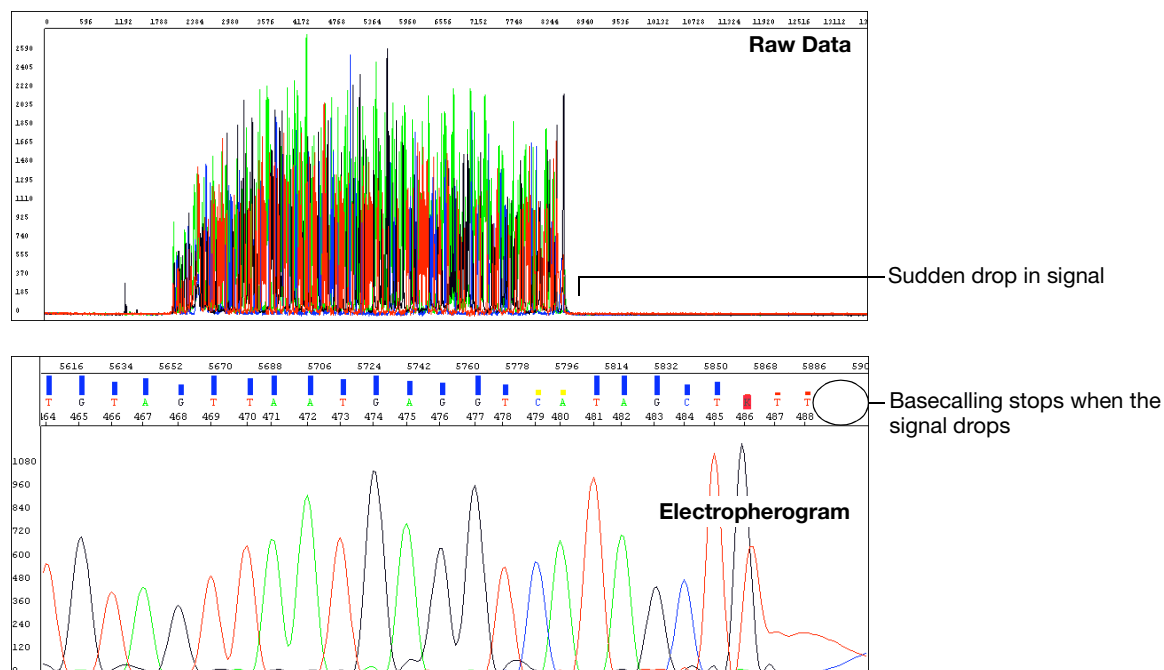
Sudden drop in signal: corresponds to basecalling stop when sequencing short template

Possible Cause(s)	Recommended Action
Data analysis issue: The drop in signal identifies a PCR stop point and the basecaller stops calling bases beyond this point. With the ABI basecaller, you observe Ns beyond the PCR stop. With the KB basecaller, the analyzed trace is displayed until the last basecall.	Select the At PCR Stop check box in the analysis protocol using Sequencing Analysis Software (see page 148).

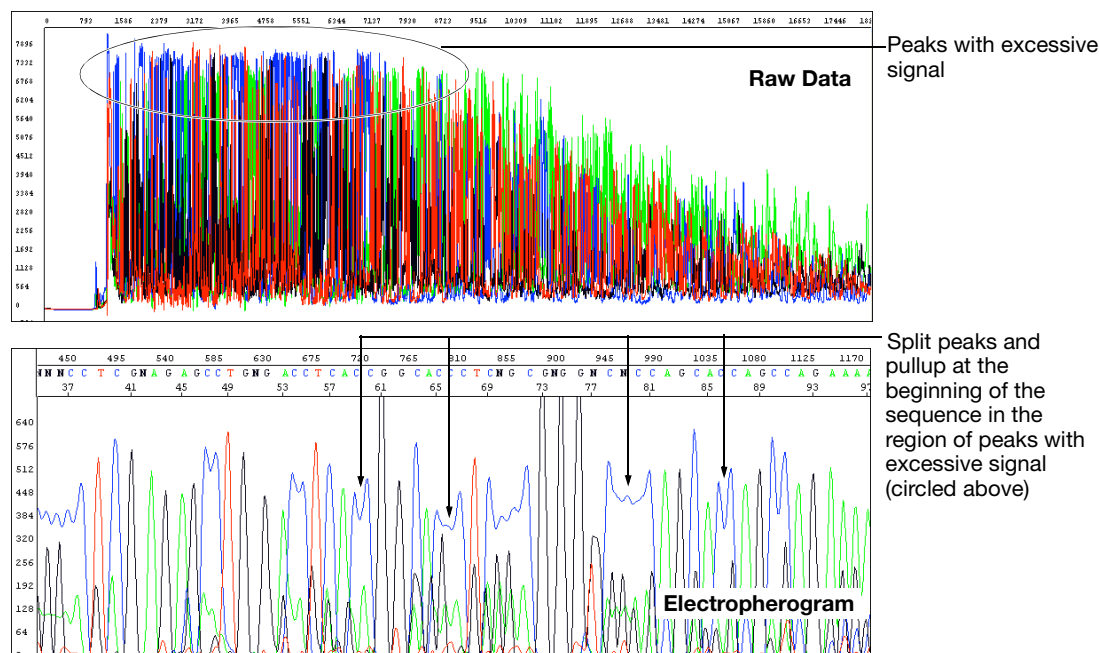
Top-heavy data: split peaks with excessive signal

Possible Cause(s)	Recommended Action
Sequencing reaction issues:	
Signal is too high because too much template was used in the sequencing reaction and too much sequencing product was created.	<p>You do not have to repeat the reaction.</p> <p>Click the Annotation tab and check the Ave Signal Intensity. Excessive signal:</p> <ul style="list-style-type: none"> 3730/3730xl instruments: >10,000 rfus 310 and 31XX instruments: >1000 rfus <p>Especially if your samples were purified using the BigDye® XTerminator™ Purification Kit, load less labeled sample by performing one of the following:</p> <ul style="list-style-type: none"> Remove some of the sample and replace with Hi-Di™ Formamide Inject sample for less time Resequence the samples, using less template in the sequencing reaction, especially if you use the BigDye® XTerminator™ Purification Kit (see Table 8, “Recommended DNA template quantities for cycle sequencing,” on page 63). <p>For future reactions, reduce the amount of template in the sequencing reaction.</p>

Injection height incorrect due to incorrect run module.	Use correct run module, especially for samples purified with the BigDye XTerminator Purification Kit (see “Selecting a Run Module” on page 137).
